Published by: Director, National Institute of Rock Mechanics

## Director's Report

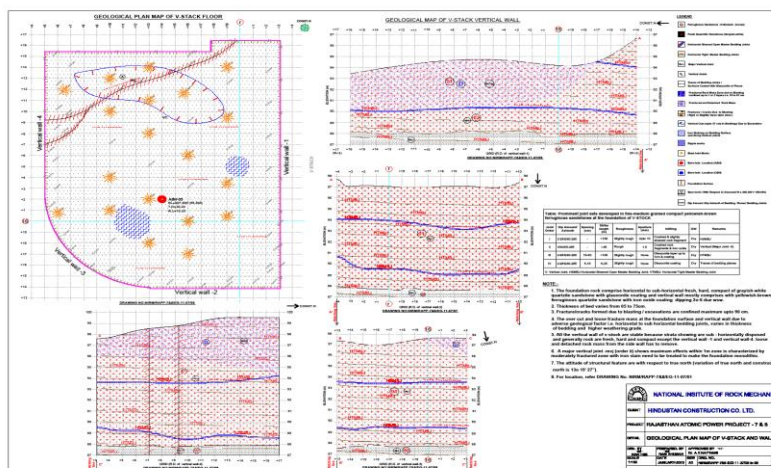
Fig.1.6 Geological Mapping of foundation floor and vertical of V. Stack building of RAPP 7&8

Due to high weathering grade at the foundation of few buildings, extra excavation were recommended up to fresh and competent rock mass before the final foundation mapping. A detailed lithological characteristics and geological structural features were mapped (Fig.1.6). In this area, particular on the walls, different weathering grade of rock were mapped. Hard, massive and competent rock masses are exposed in the entire foundation surfaces of non-nuclear buildings. Classification of rock mass using Rock Mass Rating has been done. Based on the detailed investigations, recommendations of the remedial measures for the foundations and vertical walls are given as the excavation progresses.

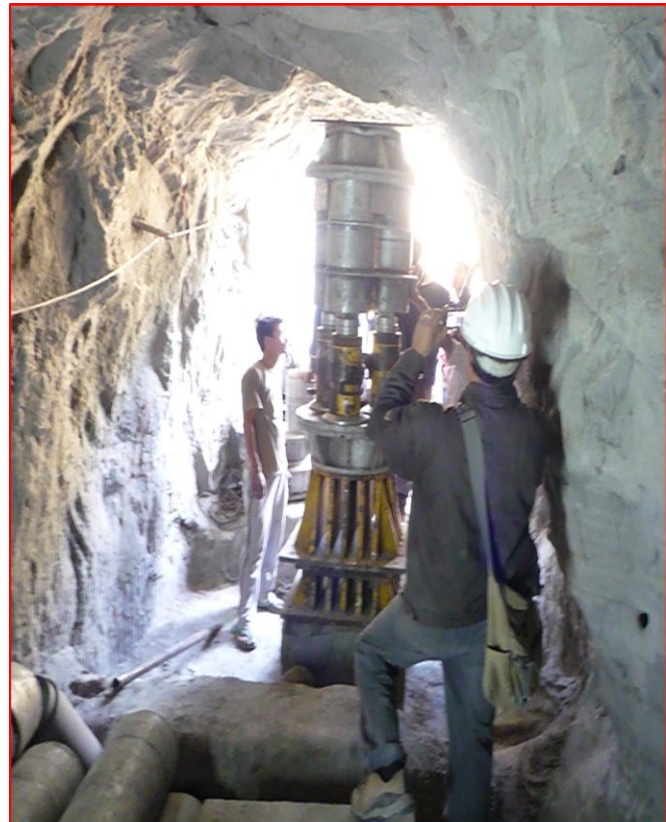
Fig. 3.2 Direct shear test set-up at the test site

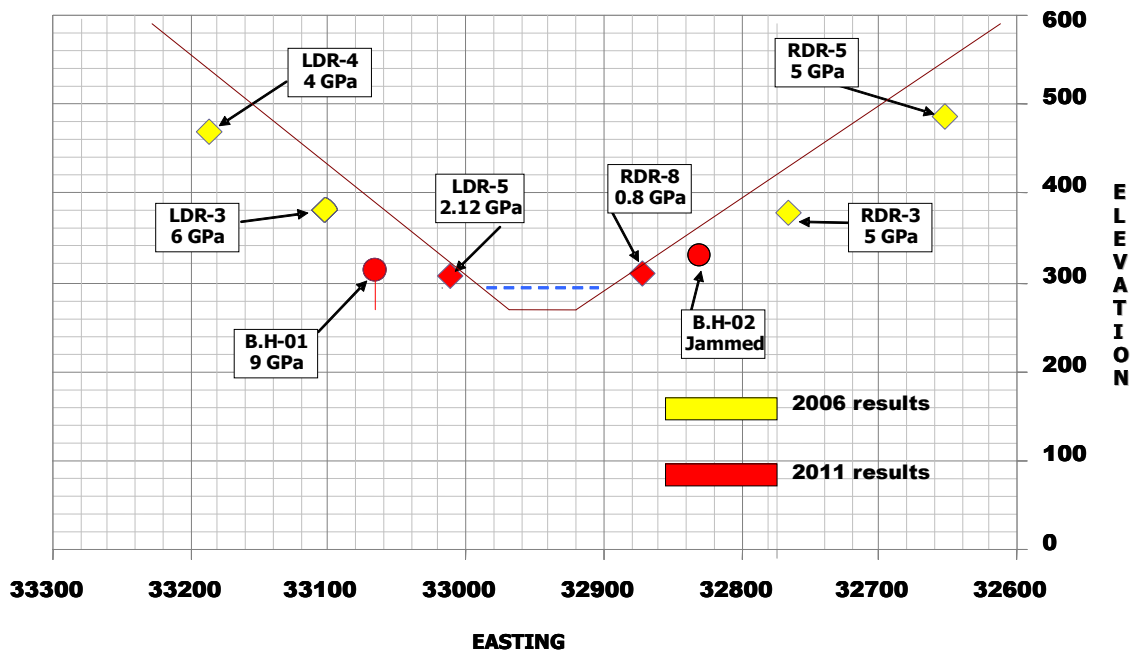
Fig 3.3 Comparison of results for deformability parameters conducted at various locations at Dibang Hydroelectric Project, Arunachal Pradesh

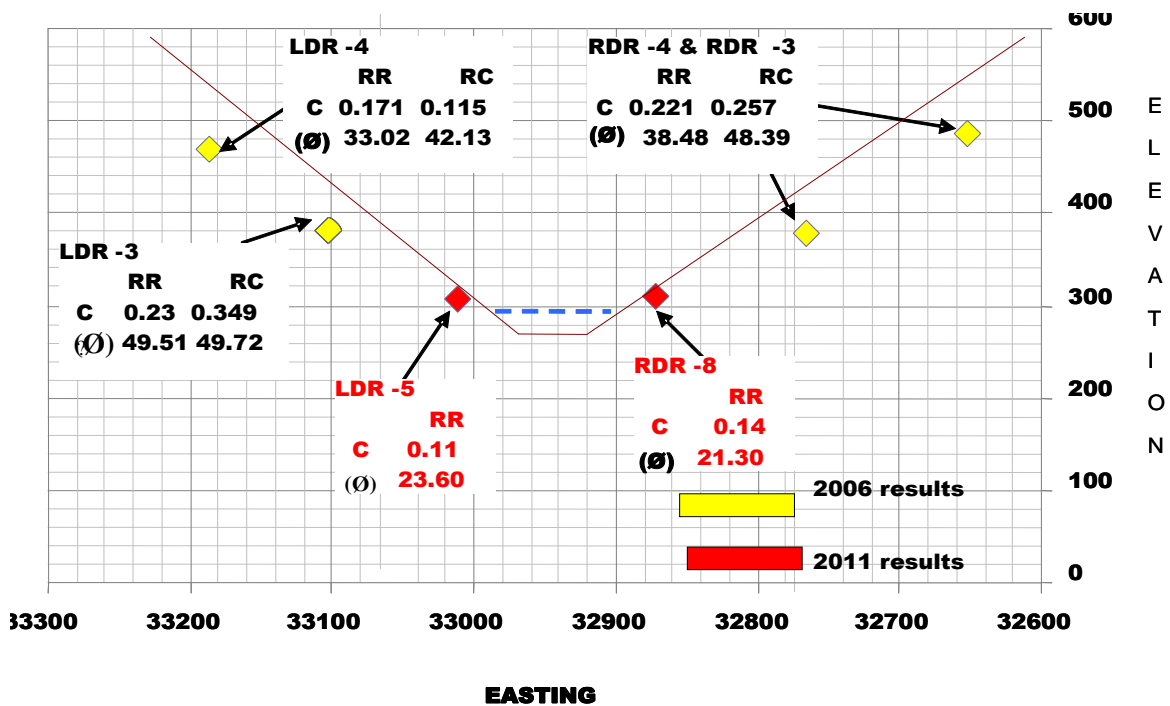
Fig 3.4 Comparison of results for conducted at various locations at Dibang Hydroelectric Project, Arunachal Pradesh

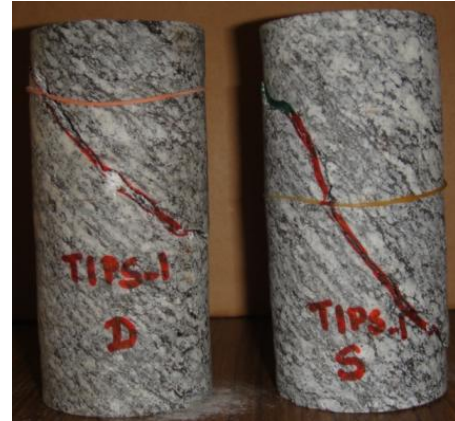
Fig. 4.2 Foliation planes with respect to core axis

Rock samples were investigated from desliting chamber, power house cavern, pressure and surge shafts and Head Race Tunnel of Tawang Hydroelectric project, stage 1 & 2. Rock properties for biotite gniess, quartzo-biotite gniess, quartzo-feldspathic gniess, quartz mica schist, quartz biotite schistose gniess and mica schist were determined under dry and water saturated conditions. Test results for the water saturated conditions show lower uniaxial compressive strength, young's modulus, tensile strength and cohesion than for the dry conditions. However, the trend was inconsistent for Poisson's ratio and friction angle. The inconsistency in Poisson's ratio is due to unusual lateral deformation at low stress levels. Friction angle is largely influenced by the nature of interface at the fracture plane and the orientation of failure plane to the principal stresses, which varied from sample to sample and is responsible for its erratic trend. In the case of biotite gneiss the friction angle for dry sample is  $31.97^{\circ}$  whereas for water saturated sample it is  $5.22^{\circ}$ . Such a large difference is attributed to the orientation of foliation plane to the core axis (Fig. 4.2).

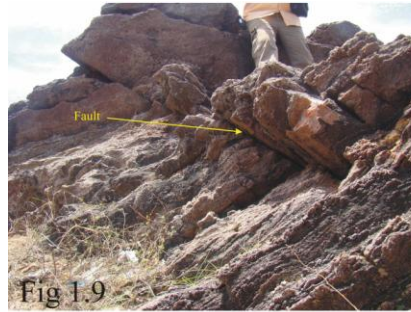
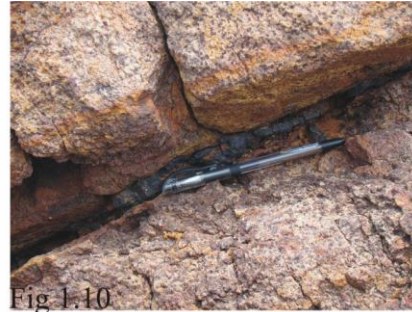
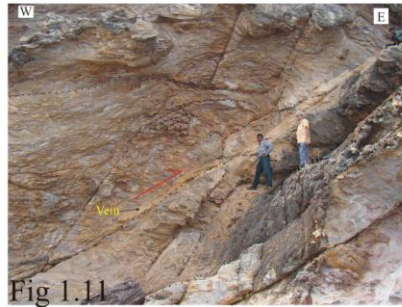
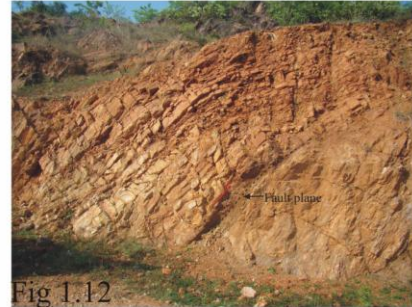
Fig. 5.3 (Top-Left) The NW-SE trending fault exposed in the Khondalite rocks. Note the sharpness of the fault plane in comparison to the weathered surface of the rocks; Fig. 5.4 (Top-Right) The black vein observed in the fault plane; Fig. 5.5 (Bottom-Left) Another NW-SE trending fault exposed in the rock section in the vicinity of the lineament NW2. Note the convergence of joints to the slip plane and discontinuous and curved joints on the hanging wall; Fig 5.6 (Bottom-Right) Photograph shows the reverse fault identified near Kanakdurga temple.

Along NW5 near Kanakadurga a major reverse movement observed in the khondalite rock. The exposure exhibits distinct structural features on either side of the slip plane (Fig.5.5). At Kottavuru dominant strike slip movement also observed in a steep NE-SE trending joint indicating movement toward NE direction (Fig.5.6). Field studies identified signatures of brittle faulting through the presence of gouge and slickensides. Fracturing and associated fluid activity has also been identified. XRD analysis identified calcite and Kaolinite as the minerals in the fracture zone.

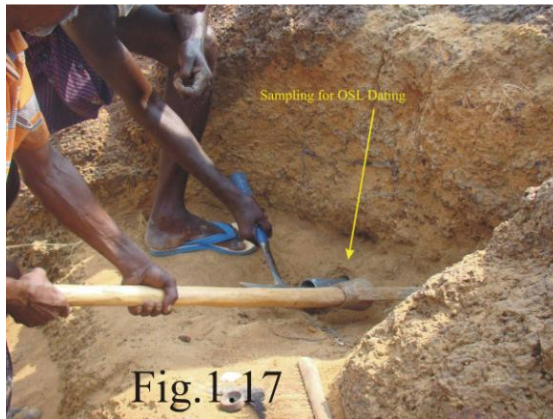
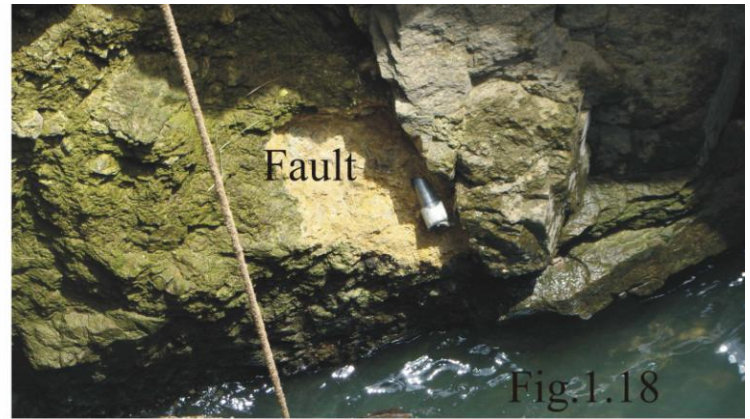
Fig. 5.11 (Left) collection of samples for OSL dating from one of the fault zones in the Ittamozhi rupture zone; Fig. 5.12 (Right) The signature of lineament N2 observed in the open well.

To find out the time of deformation, OSL dating was carried out to respective samples. The age of Aeolian deposit over undeformed laterite zone is dated as  $3.7 \pm 0.3$ . Dating of the trapped sediments within laterite due to faulting shows two different dates for the events viz.,  $1.73 \pm 0.06$  and  $4.3 \pm 0.4$  ka. This repeated events indicate the lineament L4 is active. Signature of the lineament N2 is also observed in the wells (Fig. 5.12)

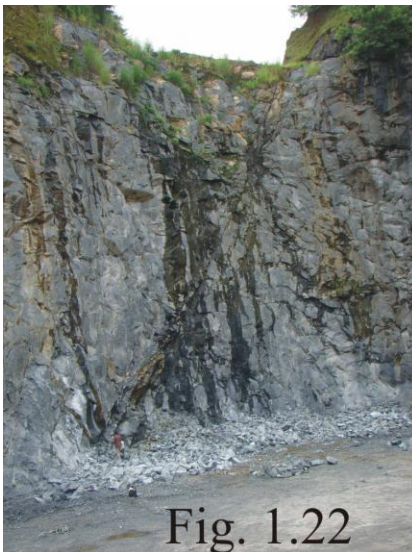
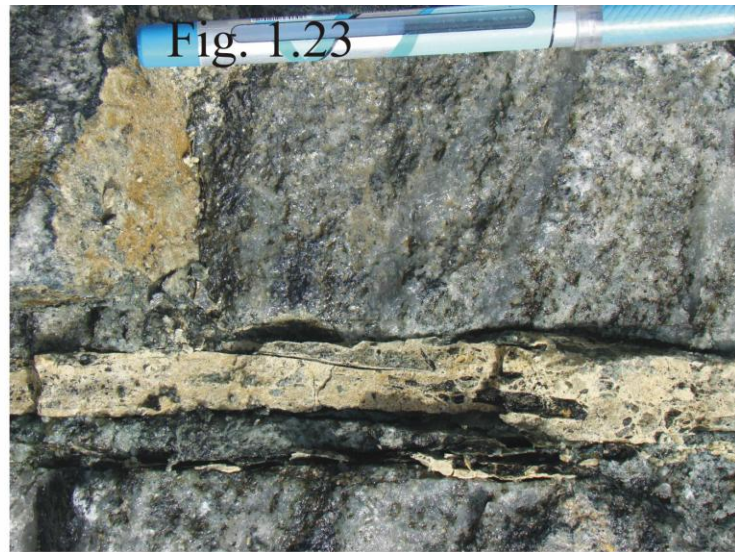
Fig.5.16 (Left) Brittle faulting observed in the charnockite extending up to the laterite cap;  
 Fig. 5.17 (Right) Fracture fill observed in the brittle fault rock.

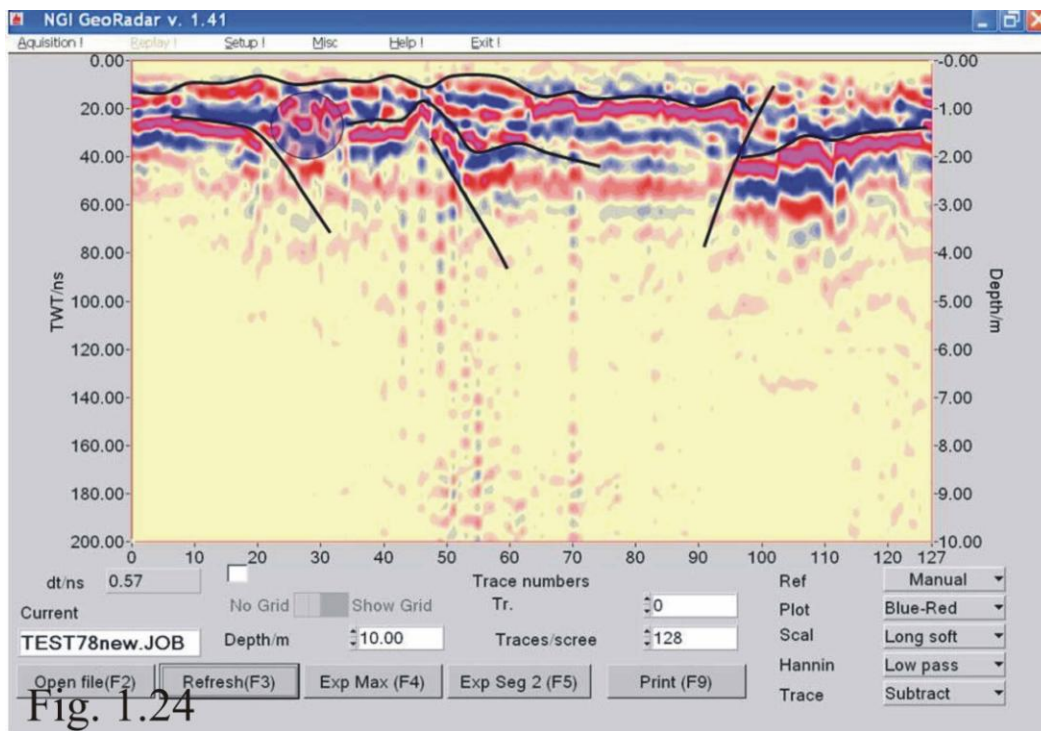
Fig. 5.18 The GPR profile showing the subsurface extension of a normal fault

As a part of the studies GPR survey was carried out across brittle faults identified near Erumapetti (Fig. 5.18). A thin top layer of lateritic soil capped over charnockite basement rock. The study reveals that the normal faults observed are confined to upper few meters of the surface. The study is continuing to evaluate paleochannels in the area by stratigraphic studies.

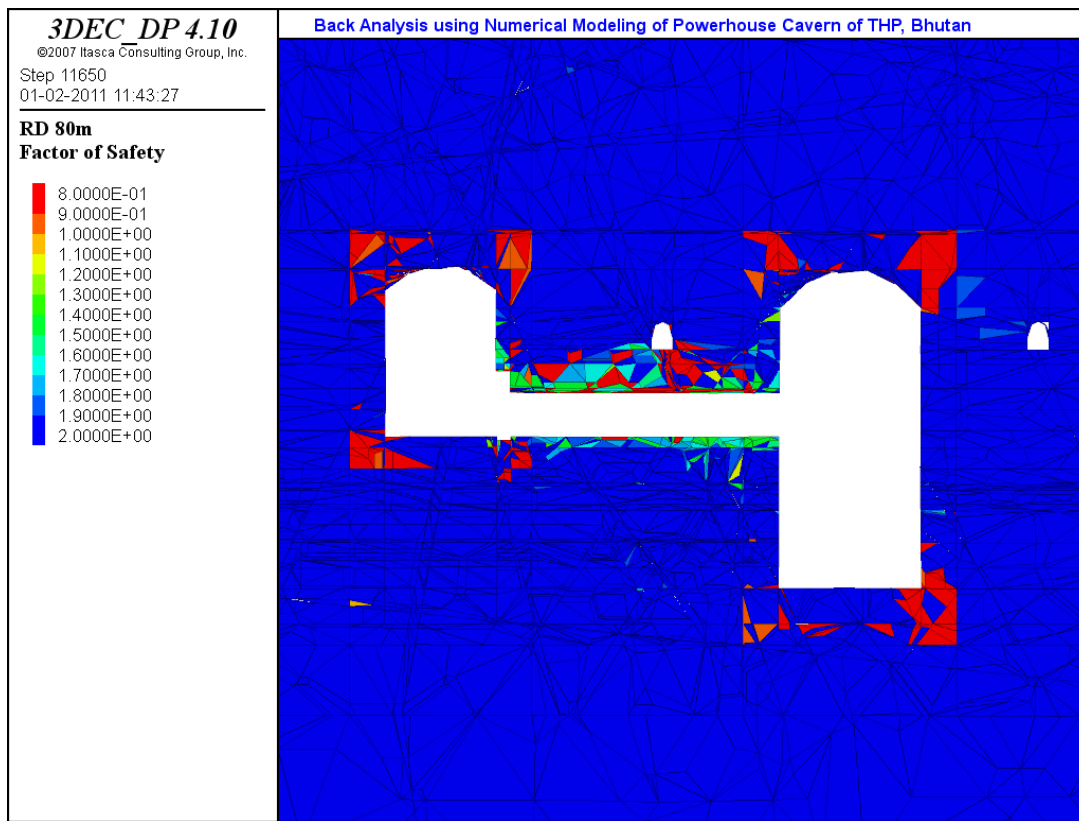
Fig. 6.2 Factor of safety contours at 80 m chainage

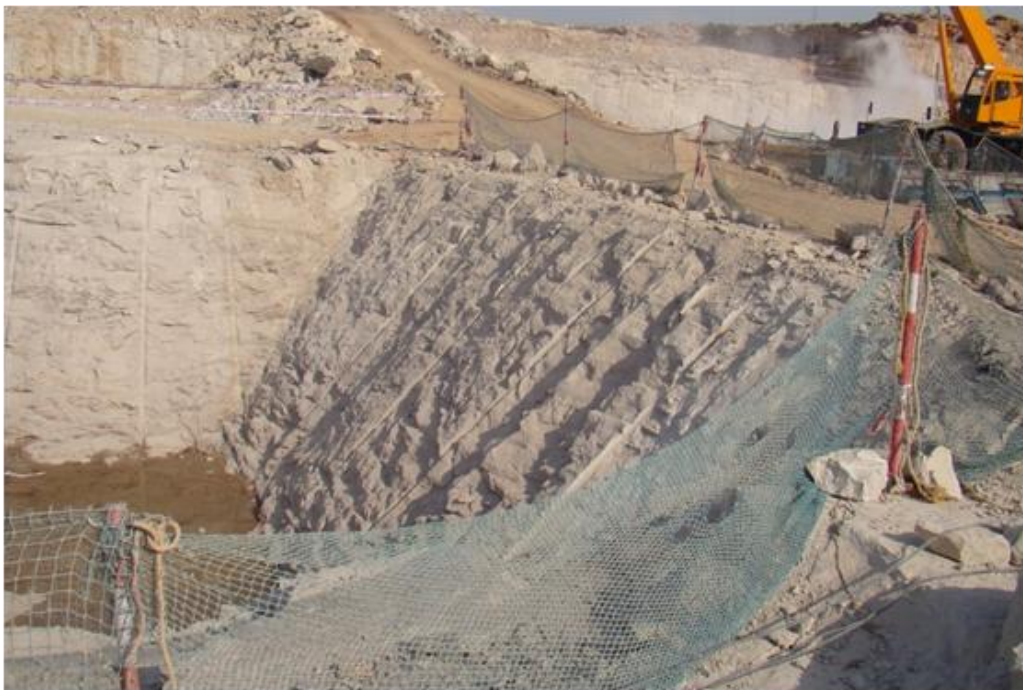
Fig. 7.1 Good pre-split blast result in hard rock in slopes

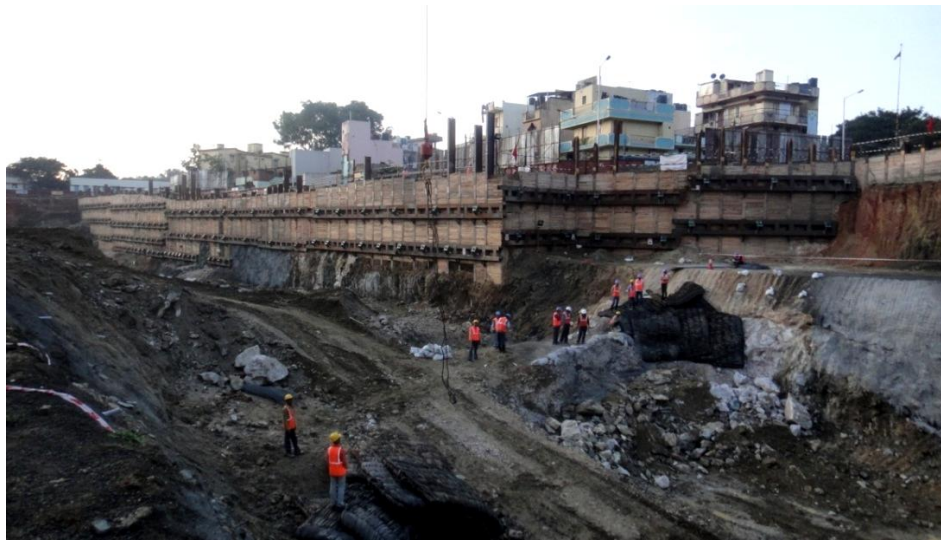
Fig. 7.6 Controlled blasting at City railway station area

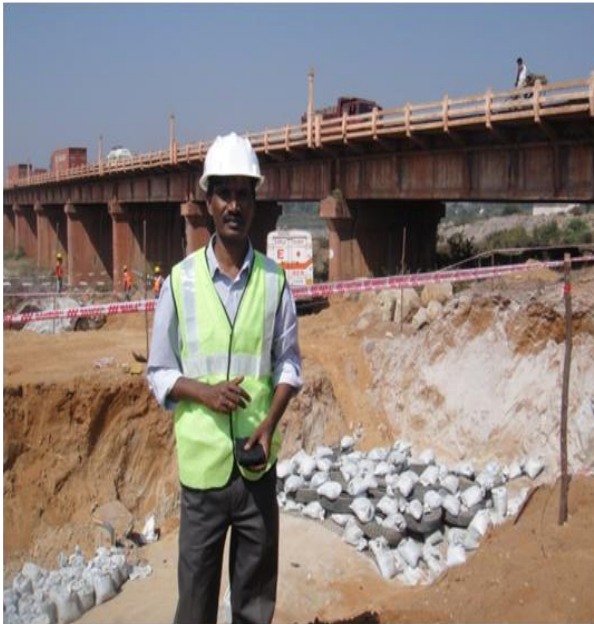
Fig. 7.8 Muffled block ready for blast adjacent to the existing bridge

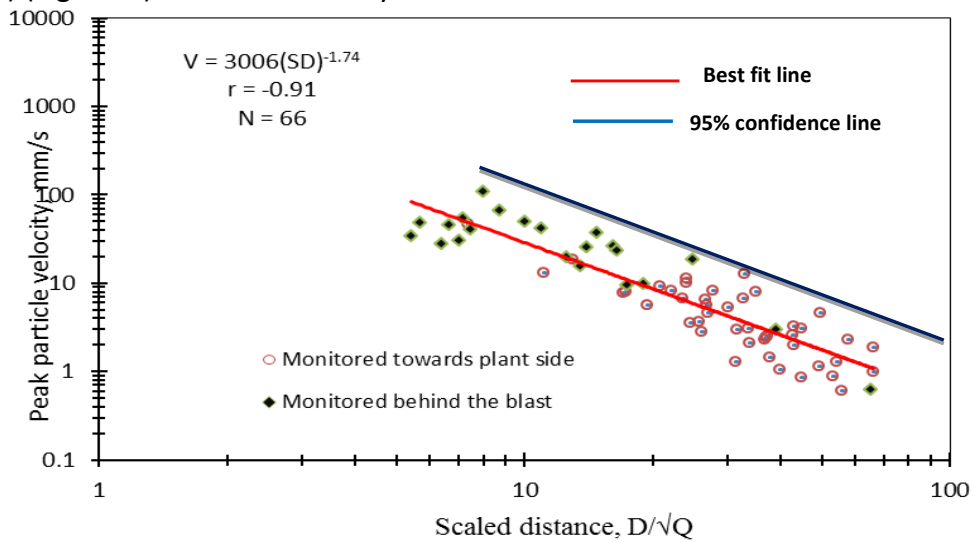
Fig. 7.10 Peak particle velocity versus scaled distance for Banswara limestone mine

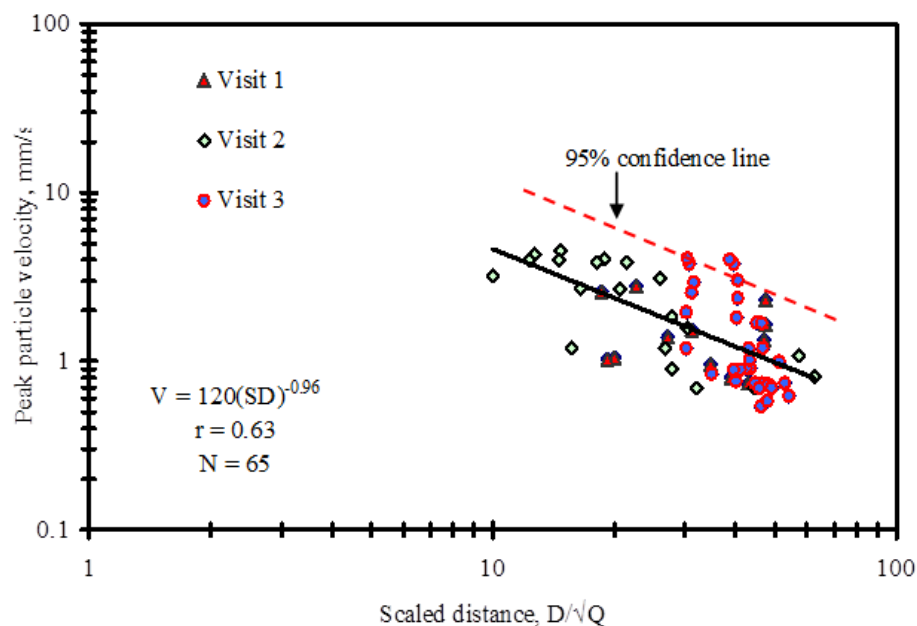
Fig. 7.12 Peak particle velocity versus scaled distance for Sengulam Augmentation Scheme

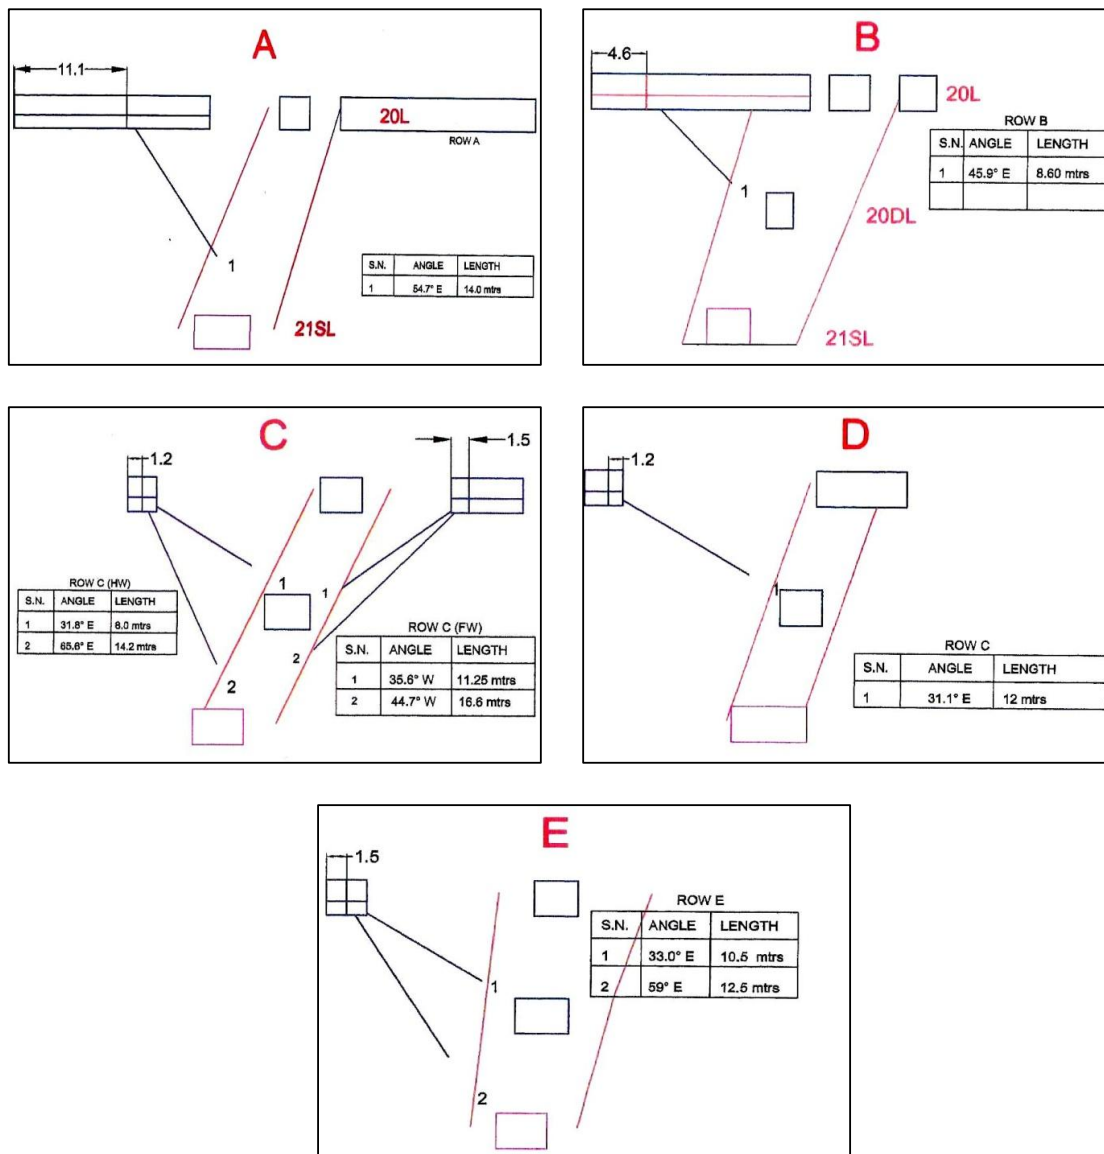
Fig. 8.1 Locations of MRMPBX installed at SR-20 level

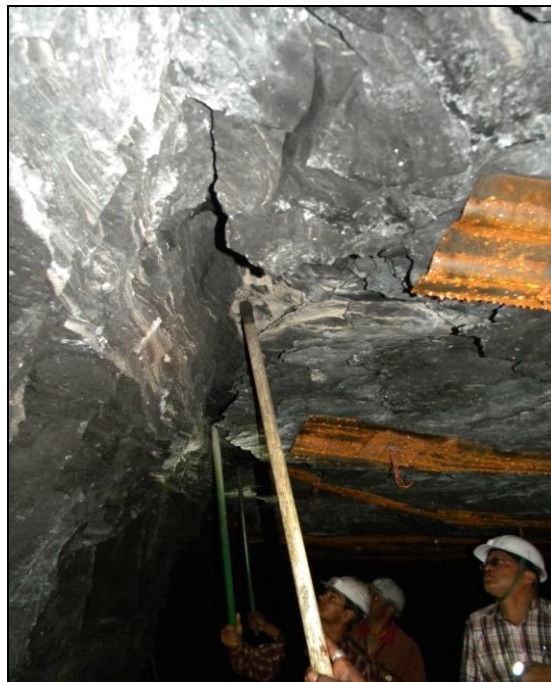
Fig. 8.2 Bad roof conditions experienced at Mathani mine, WCL

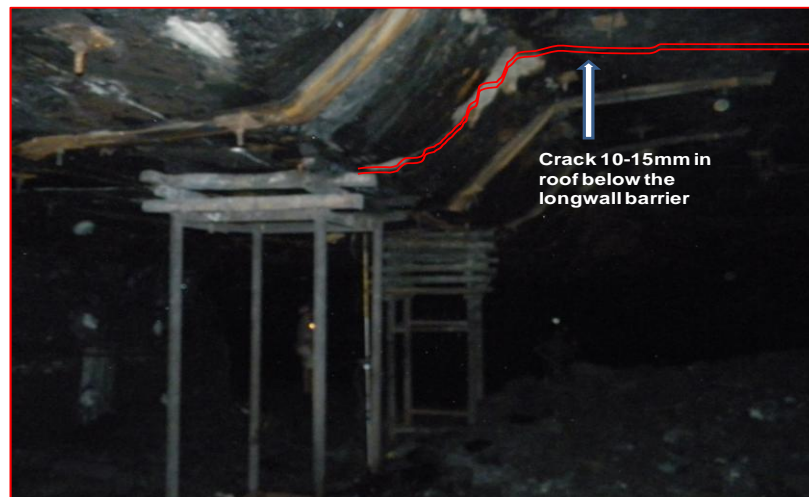
Fig. 8.4 Crack observed in CMP-3B panel below the overlying longwall barrier

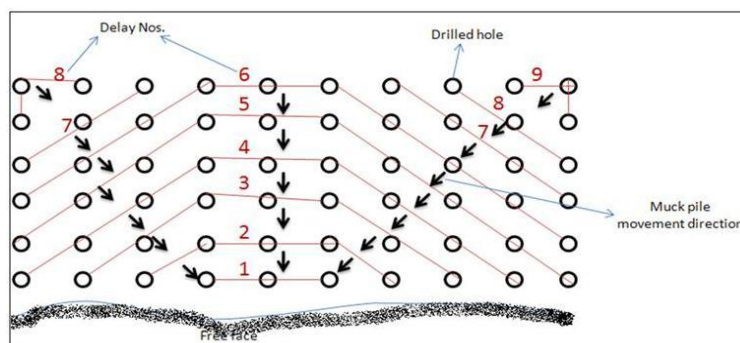
Fig. 9.3 shows the recommended blast pattern

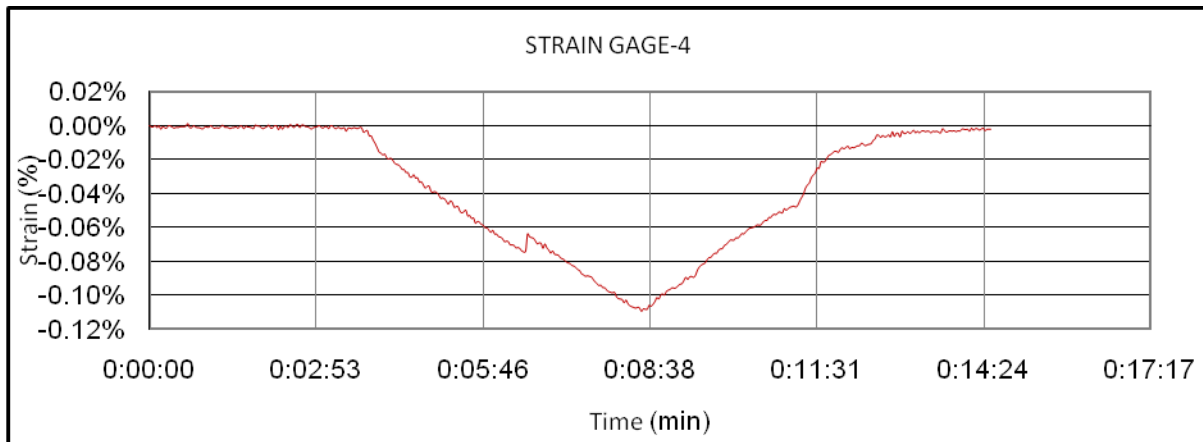
Fig. 12.4 Strain observed in one of the location

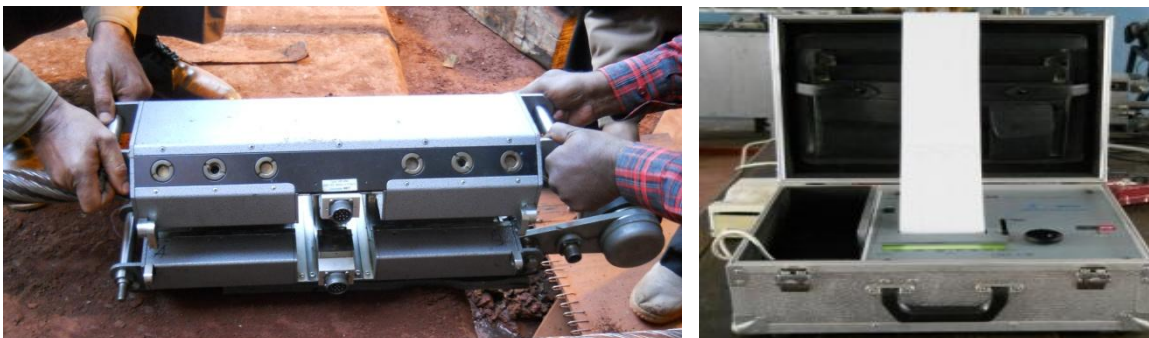
Fig. 12.5 Wire rope tester head unit and recorder (defectograph)
