नेशनल इन्स्टीट्यूट ऑफ रॉक मैकेनिक्स
National Institute of Rock Mechanics
(Ministry of Mines, Government of India)

Champion Reefs
Kolar Gold Fields – 563 117
Karnataka, India

**ANNUAL REPORT
2014-15**

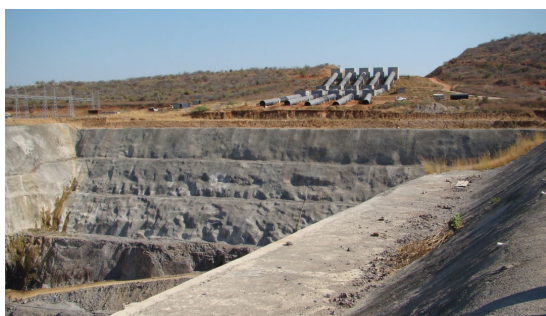
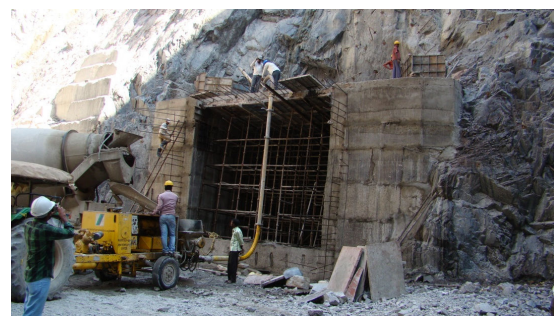
Fig. 1.1 Walls of pump house are supported with the SFRS and rock bolting

- Construction stage engineering geological investigations of the foundation levels and excavated vertical surfaces of surge pool and pump house (5x30 MW) area of Mahatma Gandhi Kalwakurthi Lift Irrigation Scheme–II, Mahaboobnagar of Telangana State were carried out. The objective was to advise suitable measures for stabilization all the sides of surge pool and pump house and to advice suitable engineering measures for the treatment of foundations of surge pool, pump house, service bay, annexure part-A and part-B based on detailed engineering geological investigations (Fig. 1.1 & 1.2). Geological mapping on the 1:200 scale of the pump house and surge pool walls and foundations was carried out using crane and traverse method. In between surge pool and pump, rock ledge was mapped, on which multiple storey annexure building is being constructed. For the granite rock masses of the walls of surge pool and pump house the assessment of Tunnelling Quality Index 'Q' was done based on the rock joints characteristics, while for granite rock mass of rock ledge between surge pool and pump house, floors of pump house, surge pool, service bay, annexure part-A and part-B the assessment of RMR was done. The excavation was delayed by more than 36 months because of the uncontrolled blasting and very unfavourable geological discontinuities in the surge pool and pump house areas. Rock on all the sides of the surge pool and pump house was partly slid, due to presence of unfavourable discontinuities and shear zones. Excavation has completed in July 2014 with great difficulty and with controlled blasting.

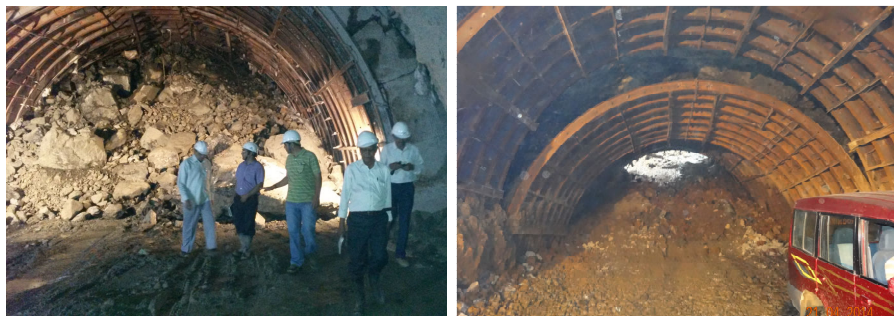
Fig. 1.3 Overbreak in left main tunnel (LMT) which was day-lighted at Ch. 3.400 km

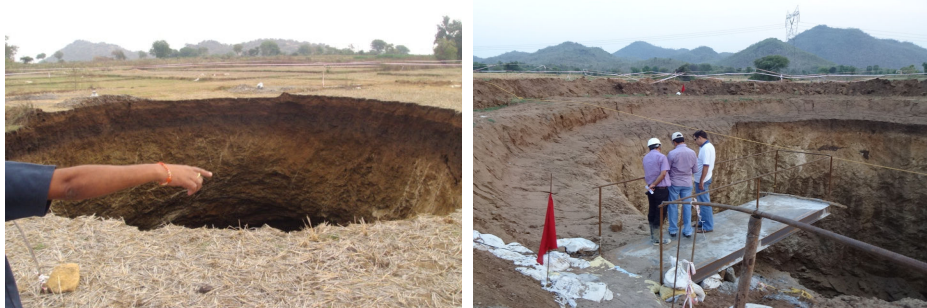
Fig. 1.4 Views of 25 m dia and 47 m deep cone shaped chimney at the surface

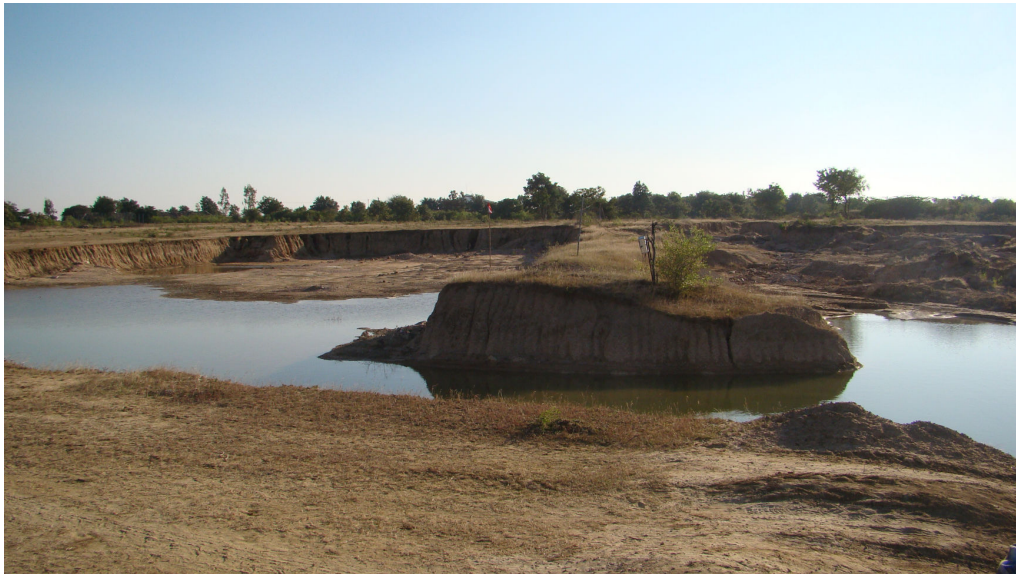
Fig. 1.5 Earlier open pump house and surge pool were proposed which are now underground structures

- The Package - 12 of Pranahitha – Chevella Sujala Sravanthi Lift Irrigation Scheme (PCSSLIS) is being constructed for drawal and lifting of 77.914 TMC of water from New Reservoir at Imamabad to New Reservoir at Tadakapally Village, Siddipet (M), Medak District by water conveyor system involving a 9.0 m dia., 9.18 km long tunnel, surge pool and pump house complex with all associated components to irrigate an Ayacut of 1,25,000 acres. Earlier open pump house and surge pool pits were proposed (Fig. 1.5). Instead an alternative underground 'Pump House Complex' was proposed by National Institute of Rock Mechanics after the site visit. Then detailed engineering geological and geotechnical investigations are carried out for the underground surge pool and pump house. The detailed investigation includes large scale geological mapping on 1:500 scale, geological logging of drill holes, in-situ stress measurements, laboratory testing on rock samples for geomechanical parameters and to conduct stress analysis of the surge pool and pump house complex using 3D modelling for a given excavation sequence, and to suggest suitable support system for roof and walls. The dimension of surge pool finalized is 350 m (L) x 15 m (W) x 44.33 m (H) and for pump house 150 m (L) x 19 m (W) x 40.5 m (H). All the investigations are completed and synthesis of data is being carried out.

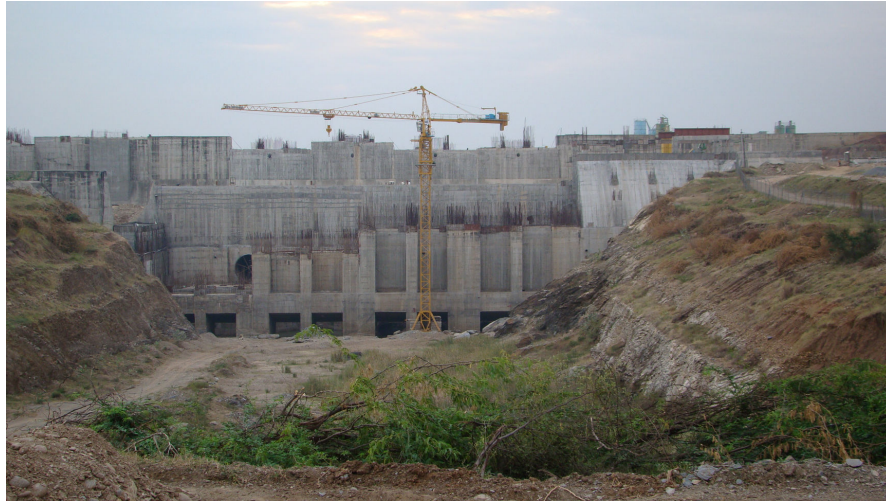
Fig. 1.6 TRP and TRC area of Pulichintala hydro electric scheme

area is occupied by foliated phyllite and quartzite belonging to Cumbum Formation of Nallamalai Group of Cuddapah Supergroup (Fig. 1.6). The assessment of RMR for phyllitic rock masses, based on the rock joints and their nature, drill holes and laboratory test data has been done. For the assessment of the stability of rock slopes, Slope Mass Rating (SMR) approach is adopted. The approach is based on modification of RMR system using adjustment factors related to discontinuity orientation with reference to slope as well as failure mode and slope excavation methods. The determination of failure modes in rock slopes are done on the basis of the geological discontinuities observed on the slope.

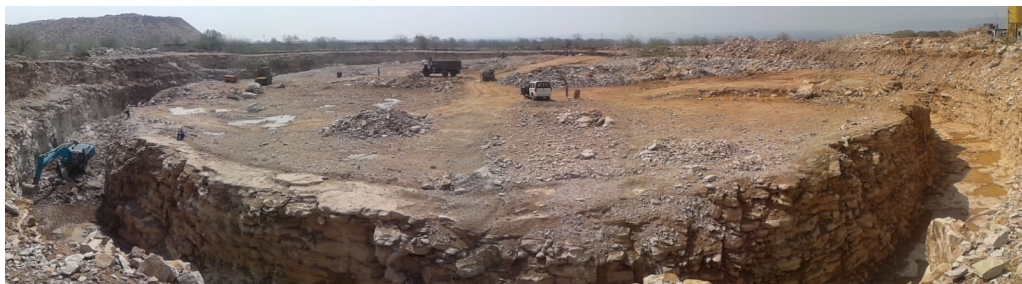
Fig. 1.7 Foundation level of NDCT-8A of RAPP Unit 8

- Construction stage engineering geological mapping of Natural Draft Cooling Towers (NDCT) of Rajasthan Atomic Power Project (RAPP) Units 7&8 are being carried out for Gammon India Limited. The investigations include large scale engineering geological mapping on 1:100 scale of foundation strata at foundation levels of NDCT 7A, 7B, 8A and 8B, identification of geological defects and recommendations of suitable engineering measures. The floors were examined on a grid to grid basis; the size of grid is 1 m x 1 m. All the lithological and structural features are observed and mapped using Total Station Surveying equipment (Fig. 1.7). Classification of rock mass using Rock Mass Rating is done and based on investigations recommendations for the treatment of foundations are being given. Three reports pertains to NDCT 7A, 7B and 8A are submitted.

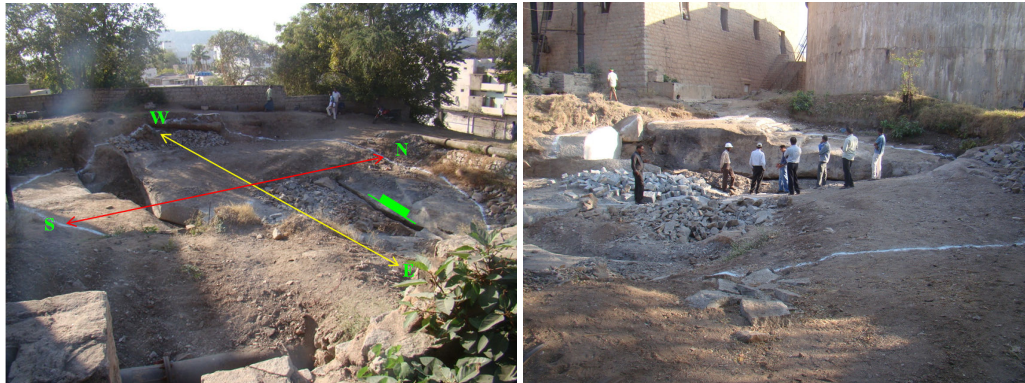
Fig. 1.8: View of foundation towards NW direction Fig. 1.9: View of foundation towards SE direction

- Engineering geological investigation of the Over Head Tank (OHT) foundation has been carried out for SNC-LAVALIN. SNC-LAVALIN has designed 1.5 million litres per day (MLD) OHT on 18 m staging for Bellary water supply project in Karnataka State. The objectives of this study are to collect the foundation engineering geological parameters and recommendations of suitable engineering measures for the improvement of the foundation. The proposed site is an isolated hillock made of grayish-white, coarse grained equigranular leucocratic granite of Late Archaean (2900 – 2600 Ma) age. The hillock is spread with massive boulders of granite rock at surface (Fig. 1.8 & 1.9). These huge massive boulders are found disconnected from the in-situ rock mass. Granite boulders are massive and fresh. Towards the northern side of this hillock, at the bottom of big boulder near the water pond and behind Devi statue, big cave is there. Based on this feature the foundation of heavy structure was shifted towards southern side during the earlier investigations. The foundation of OHT will be resting as per design on a raft of 1.5 m thick at about 2.65 m below the existing ground level for functional requirement. Field investigations are completed and final report is under preparation.

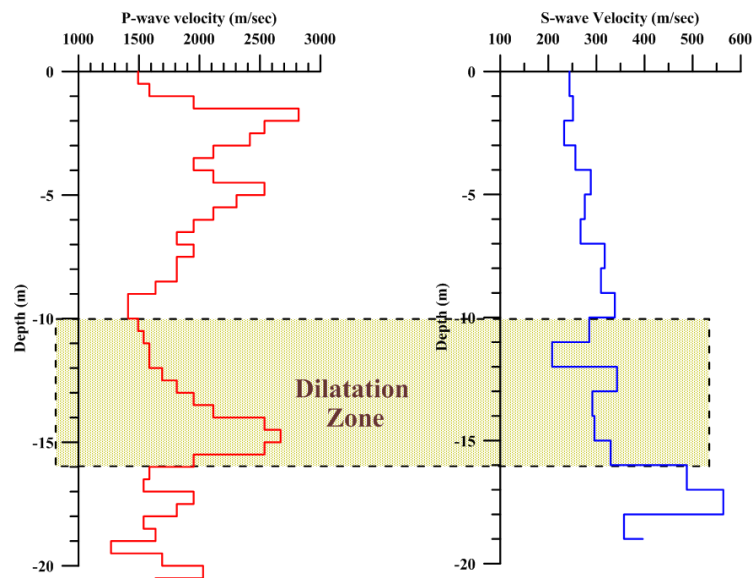
Fig. 2.7 Variation of seismic (P and S) wave velocity with depth showing plastic zone

of shear waves, similar probe with pneumatic clamping system was used. This probe can be rotated using a pipe string towards the direction of the receiver and perpendicular to the receiver. The data was collected with equal depth interval of 0.5 m. 12 channel hydrophone with a spacing of 2 m was used for receiving the signal. Both P- and S-wave velocities were plotted in the vertical section (Fig. 2.7). The survey result showed some interesting pattern. While P and S wave velocities in general increase with depth, in this peculiar zone S-wave velocity decreased while there is increase in P-wave velocity between 10-16 m depth. This type of phenomena is observed under post failure condition of rock mass and is reported as 'Dilatation' phase which is an established precursor for impending failure. So far this phenomenon was observed only under controlled experimentation in the laboratory, this was the first time evidence of a dilatation phase was noticed in a field condition suggesting an impending subsidence like failure in the near future. Based on this confirmatory inference from the cross-hole survey, entire area is now monitored by subsidence pillars to detect any abnormal trace of movement. Thus this survey established another marker of settling environment in the form of "dilatation zone".

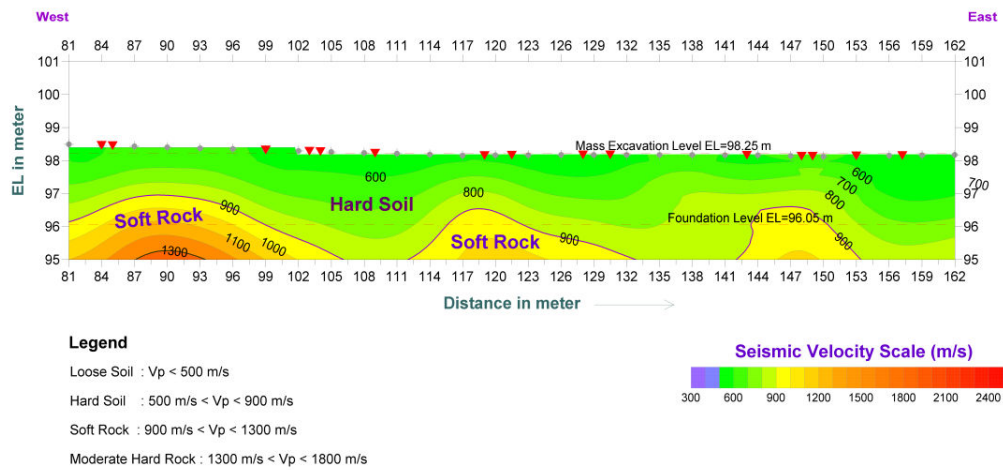
Fig. 2.9 Sample seismic velocity section along one of the survey lines

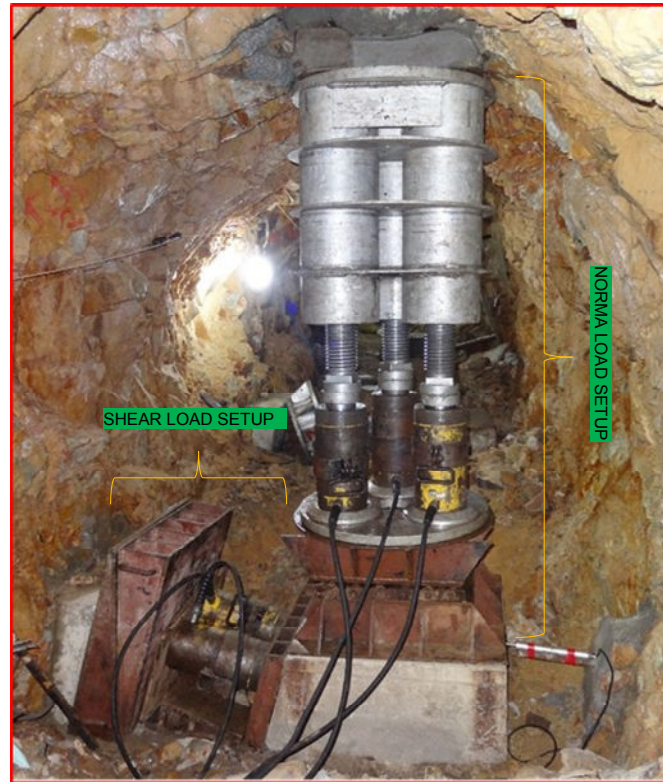
Fig. 3.1 Complete setup of direct Shear test equipment at Wangchhu HEP site

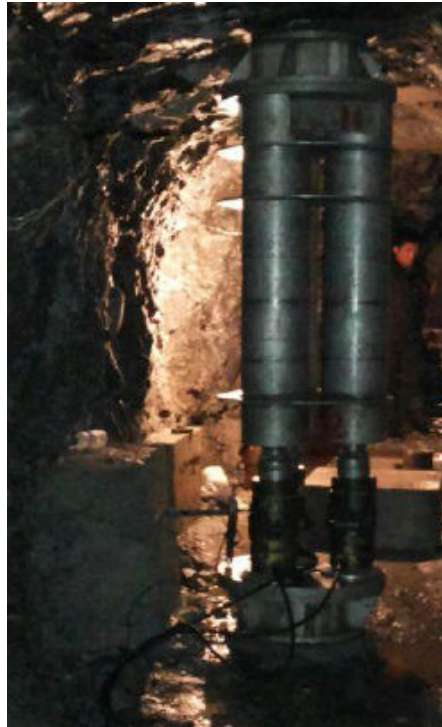
Fig. 3.3 Complete set up of Plate Load equipment at powerhouse cavern of Teesta-IV hydroelectric project

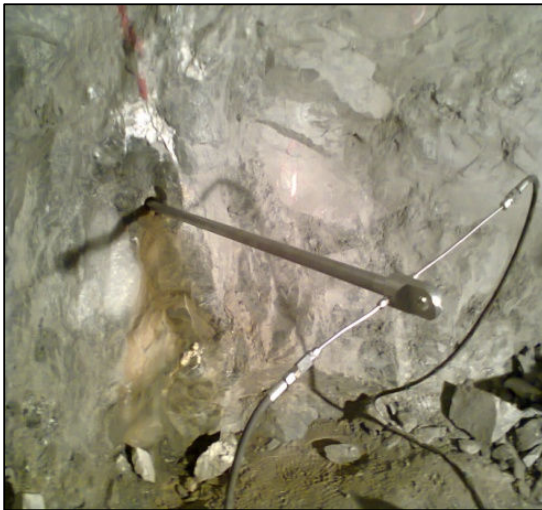
Fig. 3.4 Straddle packer & twin tube system

situ stresses were measured inside these boreholes by hydraulic fracturing (Fig 3.4) method using either a (high) viscous fluid or (variable water) manipulation of flow rate or combination of both. The stress evaluation was made using latest software. Stress measurements were conducted by using different flow rates of water inside the fractured rocks. The stresses evaluated by this method was correlated with normal flow rate hydraulic fracturing method at the same locations where the rock mass was not fractured. Stress measurements were conducted by hydraulic fracturing method by using high viscous liquid in porous rocks. The stresses evaluated by this technique were correlated with stress measured by overcoring method. The stress measured by overcoring (Fig 3.5) method was used as bench-mark as this method does not suffer from the presence of porosity of the rock. The correction factor was introduced in the stress evaluation by hydraulic fracturing method in fractured and porous rocks. This new technique will be helpful in conducting the stress measurements in porous and fractured rocks, which will be highly beneficial to both mining and hydropower related excavation.

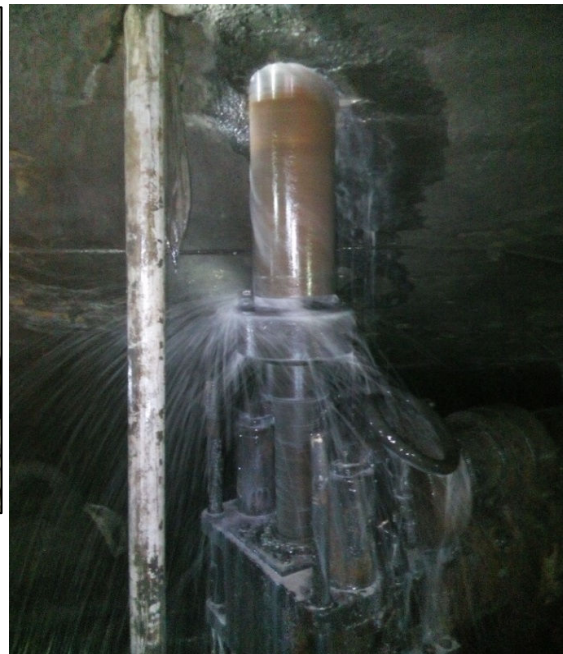
Fig. 3.5 Overcoring test at KTK-8 Incline

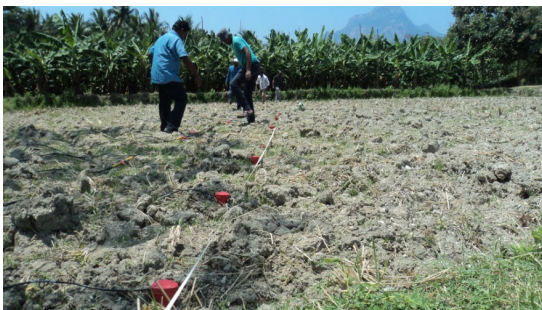
Fig. 4.1 MASW survey carried out across L2 lineament

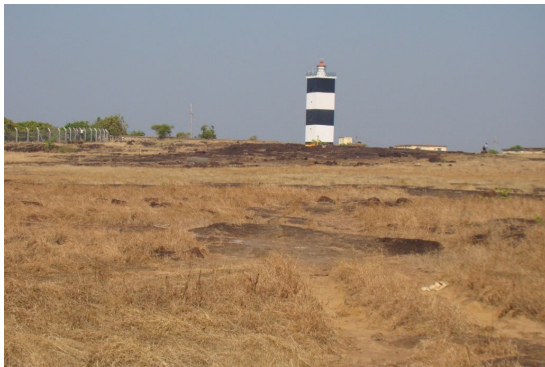
Fig. 4.4 View of light house lineament; the elevated portion is the scarp being studied through trench investigations

- A lineament was identified within 5 km radius of the proposed Jaithapur Nuclear Power Project (JNPP) site (Fig. 4.4) during geological studies carried out by GSI. Subsequently a group of experts recommended geological investigations in trench for identifying the lineament and its related subsurface features up to rock level. Accordingly, NIRM was entrusted with the investigations. After preliminary geological, geomorphologic and literature surveys, the trace of the lineament was marked based on the geomorphic expression mentioned in the GSI Report, during a joint visit of NIRM, AMD and NPCIL. The study culminated in the design of 100 m (L) × 21 m (W) × 27 m (D) trench for the purpose, one of the largest trenches made for palaeoseismological studies in the world. To facilitate mapping at 1:20 scale, the trench was excavated with depth interval of 2-3 m in 10 stages. To maximise information collection from the trench, excavation was done in three parallel narrow trenches till stage 7 (Fig. 4.5), cleaned trench faces and floor for facilitating identification structural features and detailed mapping in 1 m × 1 m grids (Fig. 4.6 and Fig. 4.7). The trenching exposed 7-8 m thick laterite cap overlying laminated clay. Comprehensive organisation and analyses of various data, constituent analyses and dating rock and soil samples is in progress.

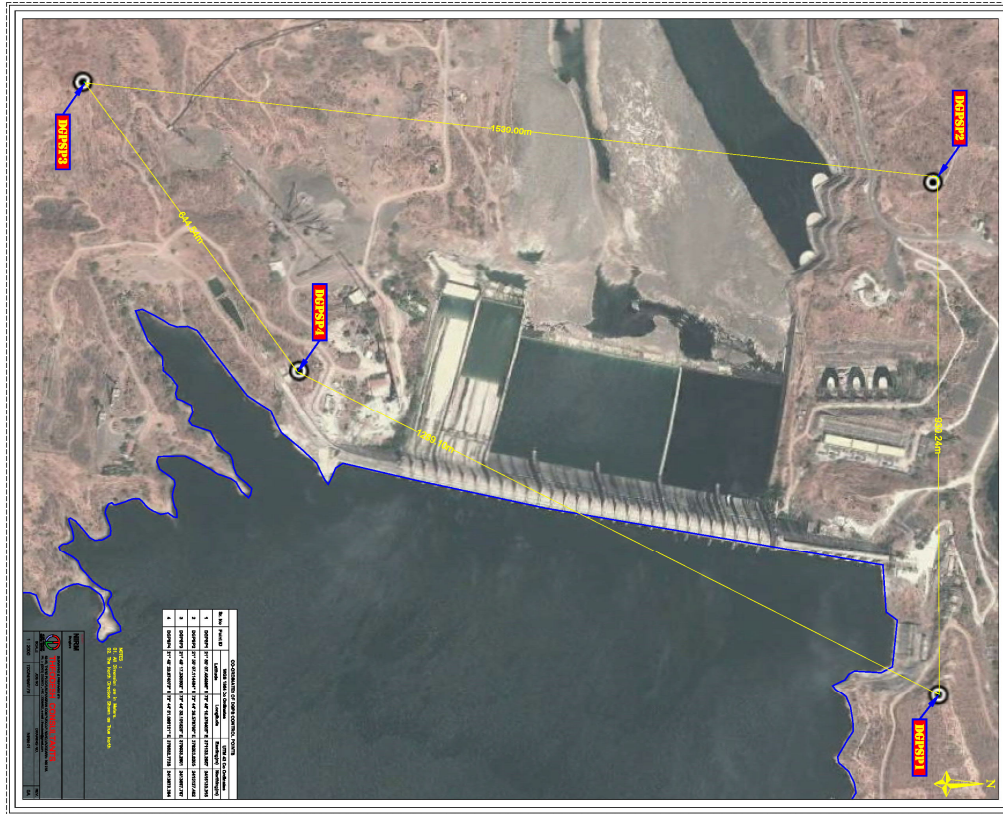
Fig 5.1 Control points network at SSNNL Dam

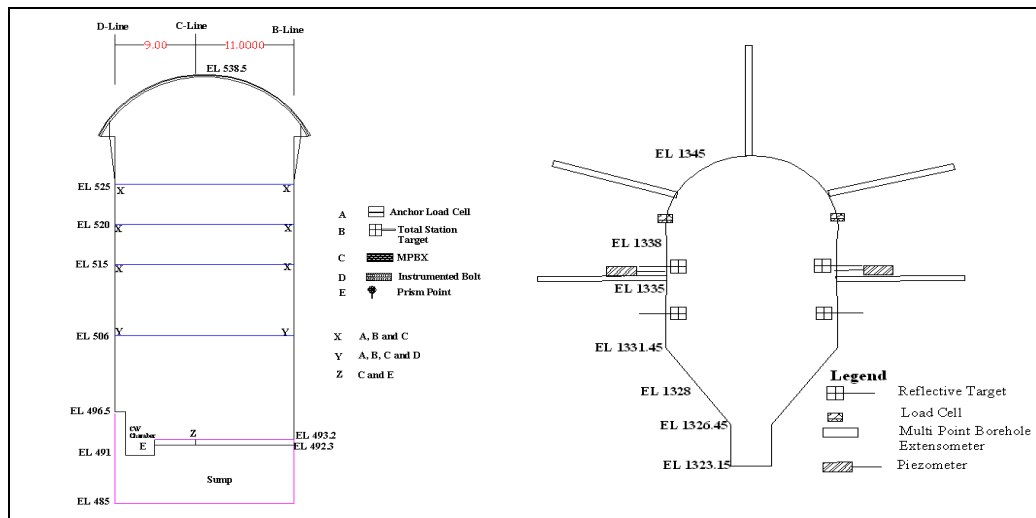
Fig. 5.2 Location of instruments in a section of machine hall cavern and desilting chamber

chamber. Stability of the machine hall cavern was assessed based on convergence observations of the side walls, load on the rock bolts and stress distribution along the length of instrumented bolts and piezometric observations in the side walls. The actual instrumentation section installed at Machine Hall Cavern and Desilting Chamber is shown in Fig 5.2.

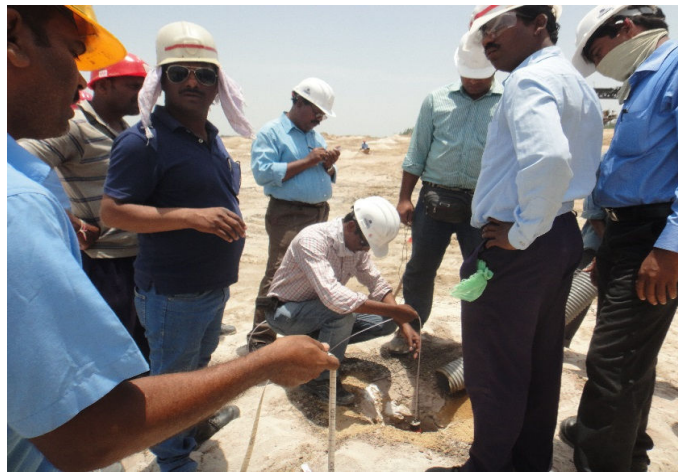
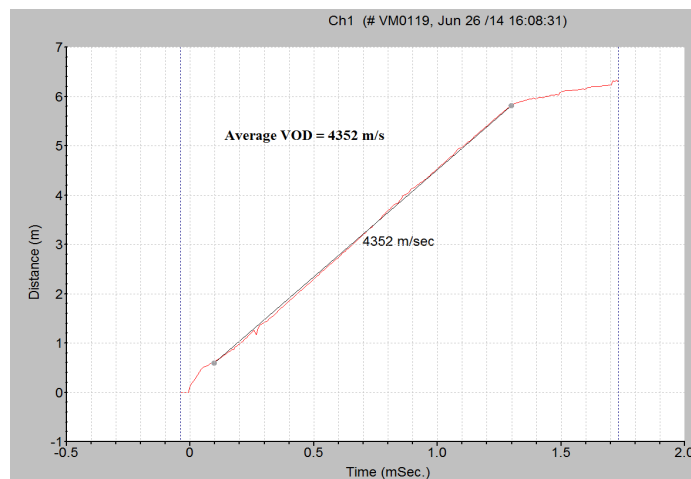
Fig. 6.5 Preparation of VOD monitoring and average VOD value for one of the blast

bore hole mechanically convey the ANFO into a borehole. The VOD study for ANFO in real time was conducted at OCP I, RG III area of SCCL. The mine is fully mechanized operated in benches with the height varies from 10 m to 27 m. The 250 mm diameter holes are blasted using 634 series Site Mixed Slurry (SMS) explosive with shock tube initiation system or detonating cord and cord relays. Trials with ANFO in combination with non-electric shock tubes were conducted at different benches. The blasts were bottom initiated with down the hole detonators. The VOD was tested for both SMS and Site mixed ANFO. All the tests were carried out in sandstone benches of 10 to 14 m bench height. The continuous resistance wire method was used to measure the VOD using the probe cables of two different suppliers with known resistance per meter and two different VOD Monitors were used for the study. The VOD records were analysed using software provided along with the equipment. A total of 5 blasts were monitored measuring 11 holes out of which 4 blasts were successfully recorded and analysed for 6 holes. Fig. 6.5 illustrates the preparation of VOD monitoring and average VOD value for one of the blast. The report documented the highest and lowest recorded VOD value of ANFO as 4358 m/s and 4252 m/s respectively. Similarly for SMS 5305 m/s and 4467 m/s.

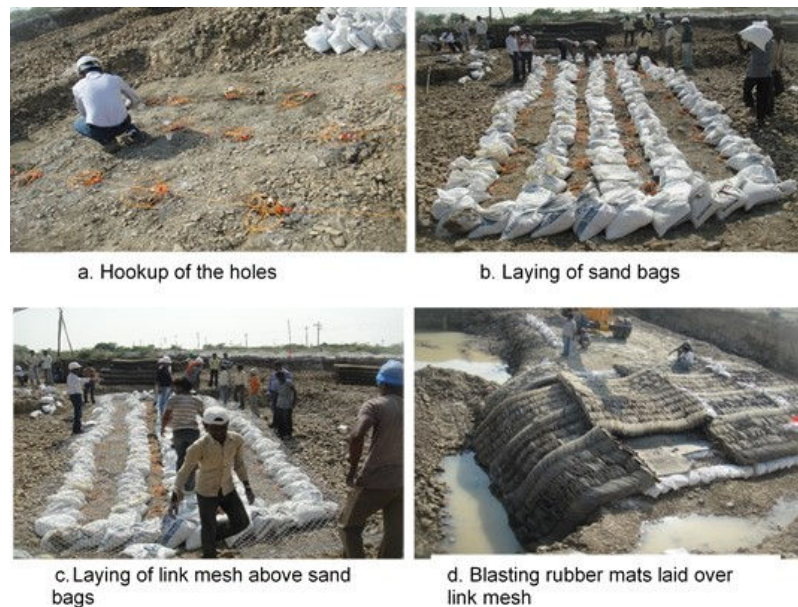
Fig. 6.6 Photographs showing sequence of muffling

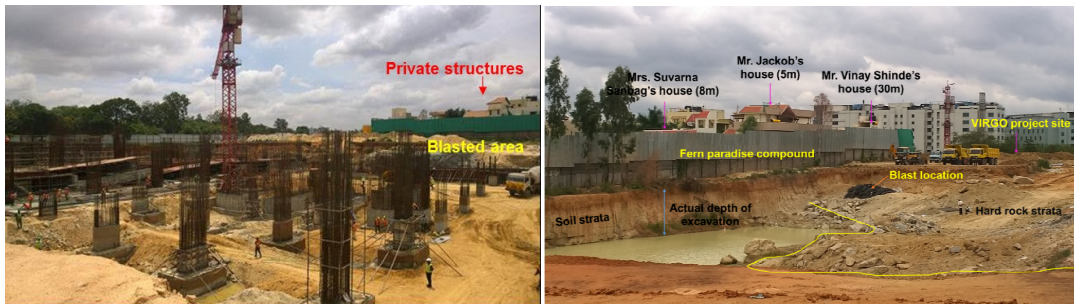
Fig. 6.7 Photograph showing post excavation & construction activity at Virgo tower area

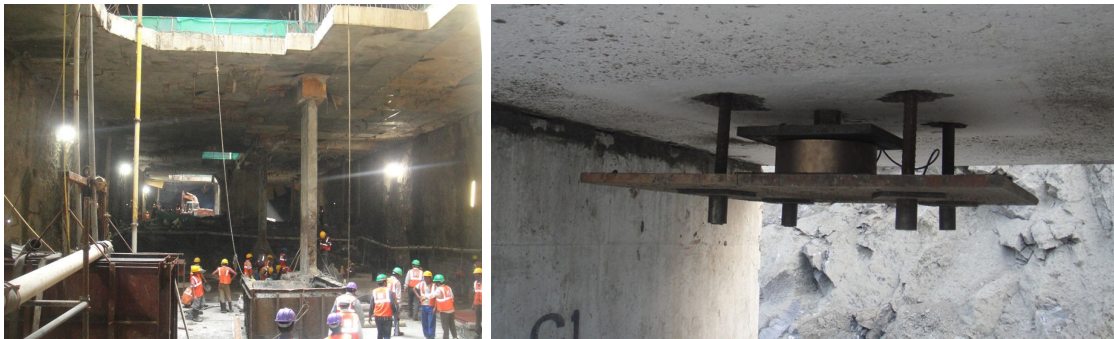
Fig. 6.9 Photograph showing blasting to be carried out under an RCC roof
 Fig. 6.10 Load cell mounted inside roof of the precast concrete structure at an alternate site to monitor load exerted by the explosive pressure

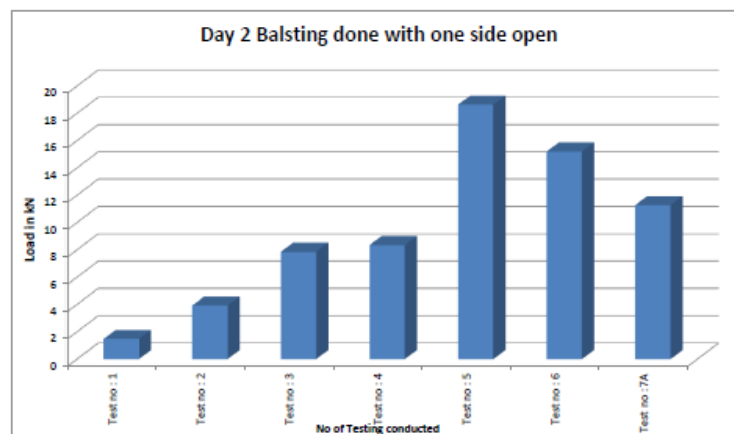
Fig. 6.11 Response of the load cell for the blasts conducted (one side open)

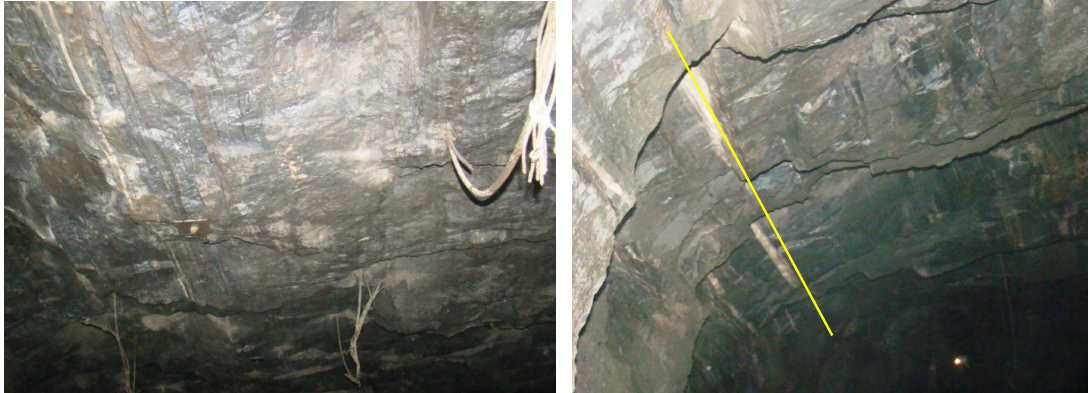
Fig. 7.2 Banded texture (foliation) in ore zone, and lineation and bedding planes at Chikla mine, MOIL Ltd

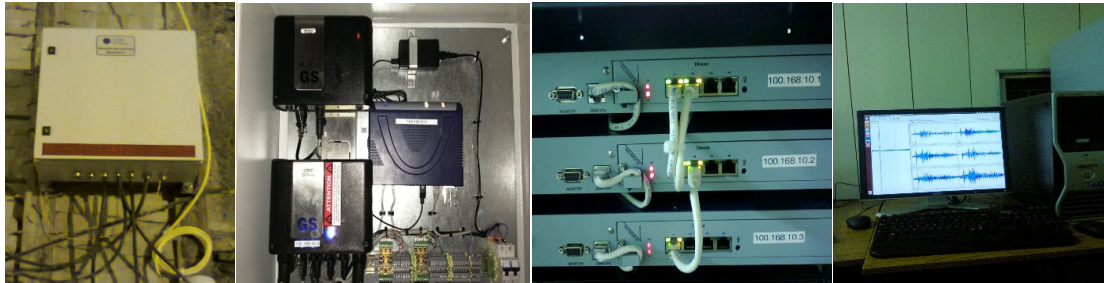
Fig. 8.2 Installed nanoseismic instrumentation at TVHPP

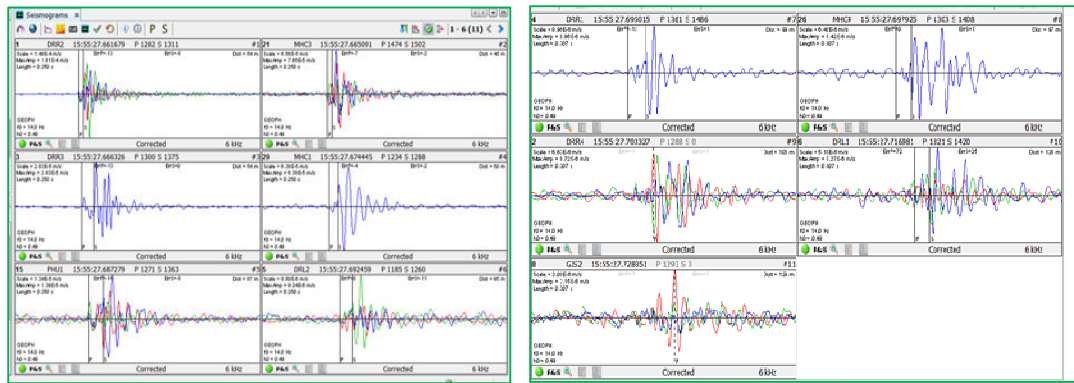
Fig. 8.5 Seismic signatures of the rock bolt physical ejection from rock

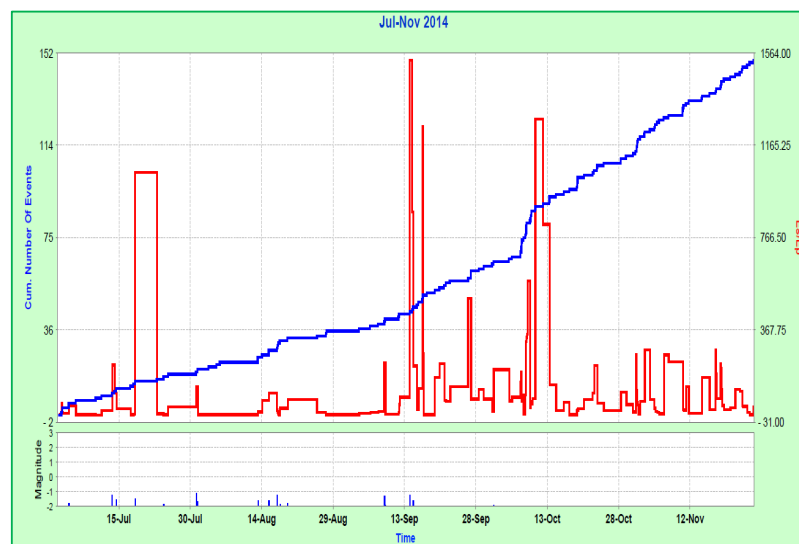
Fig. 8.7 Es/Ep vs. CAV time history for the data July-November 2014

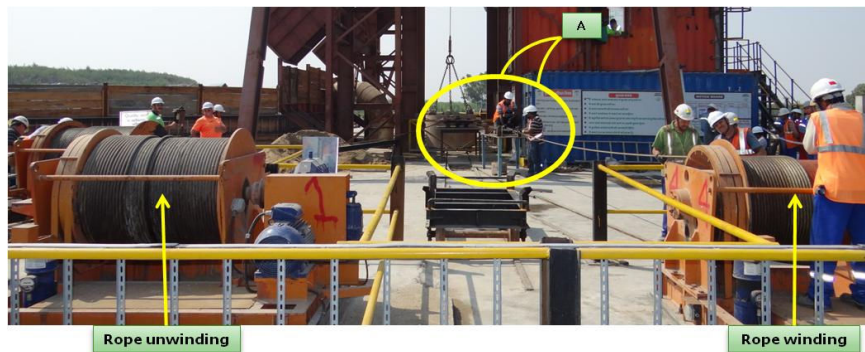
Fig. 9.2a Special arrangement made at the site for testing the winch ropes, South Ventilation Shaft

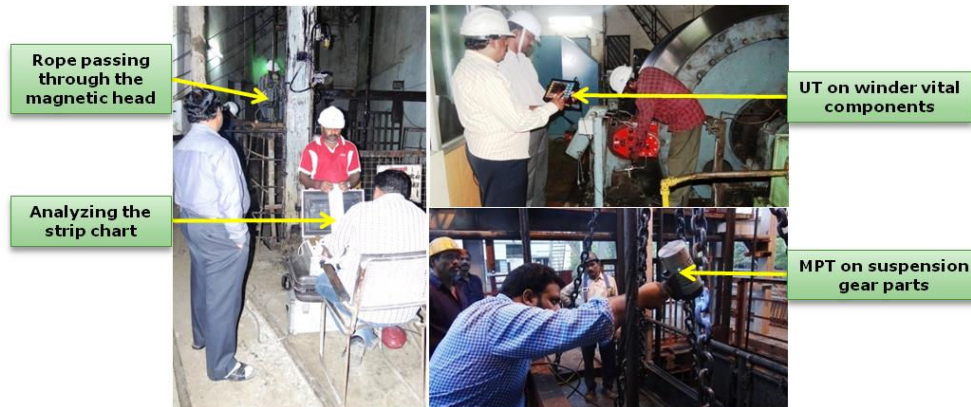
Fig. 9.3 NDT on winder vital components, suspension gear parts and wire rope inspection

skip winder at main shaft and one rope of cage winder at main shaft as they were found to have isolated fatigue cracks.

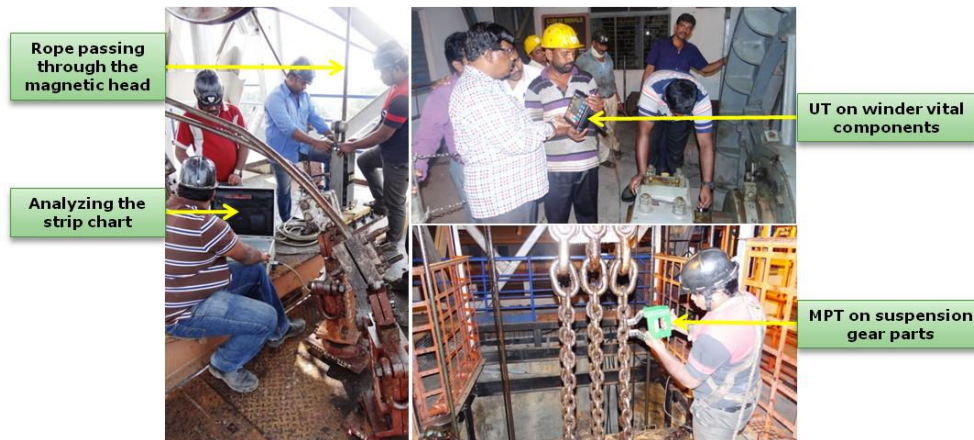
Fig. 9.5 NDT on winder vital components, suspension gear parts and wire rope inspection of various mines

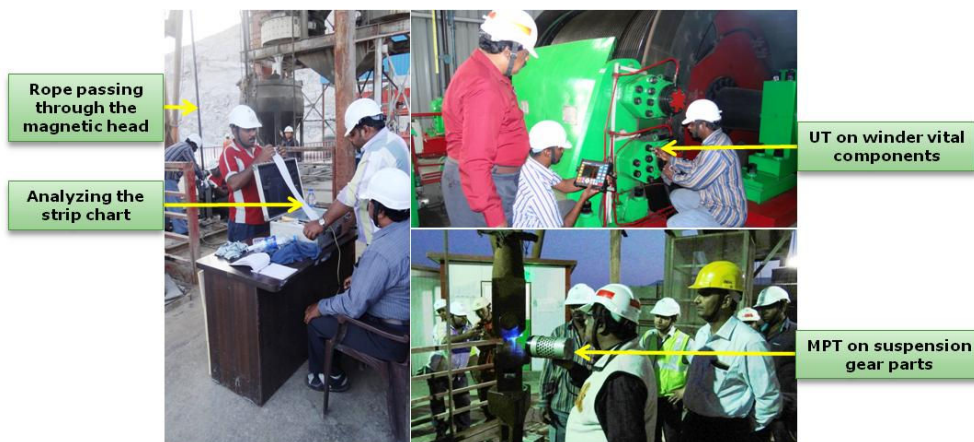
Fig. 9.6 NDT on winder vital components, suspension gear parts and wire rope inspection

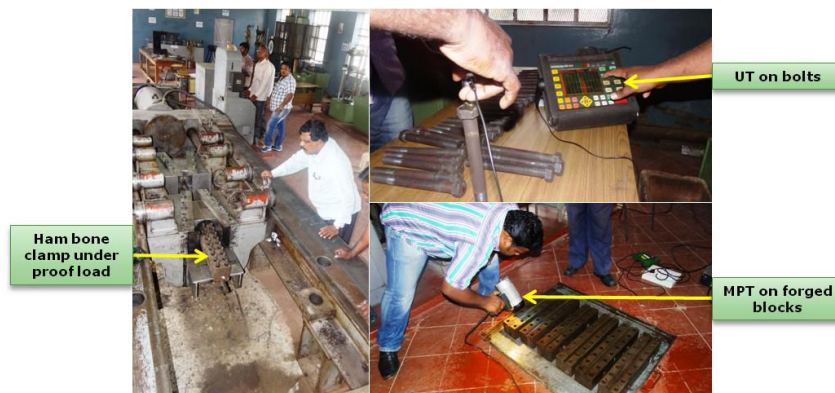
Fig. 9.7 Proof load test and NDT on 16 bolt ham bone clamps

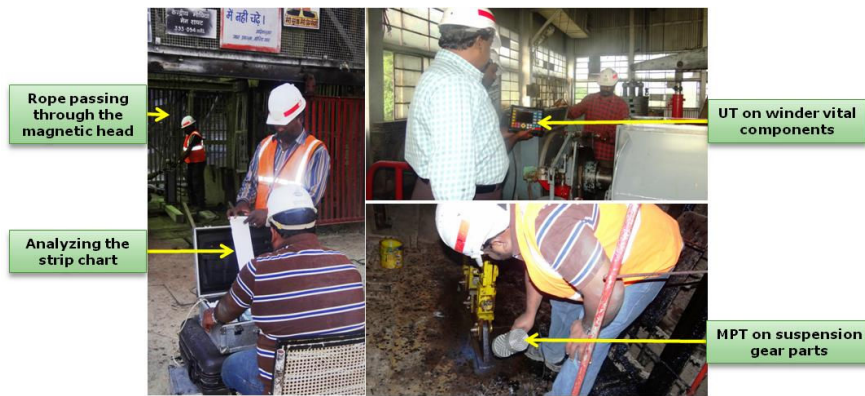
Fig. 9.8 NDT on winder vital components, suspension gear parts and wire rope inspection

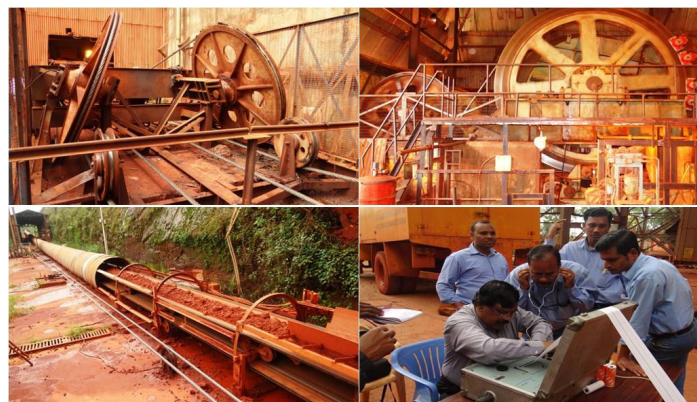
Fig. 9.9 Inspection of cable belt drives

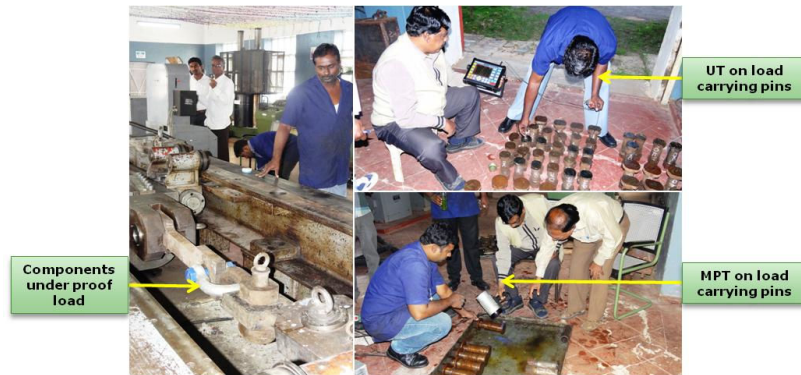
Fig. 9.10. Proof load test and NDT on bucket bows, load carrying pins and D-shackles
